SERVICE BULLETIN
#LO-006

RE: Rear Receiver

OVERVIEW: This Service Bulletin covers the inspection and bracing of the rear receiver.

MODELS: Little Guy Max & Little Guy Mini Max.

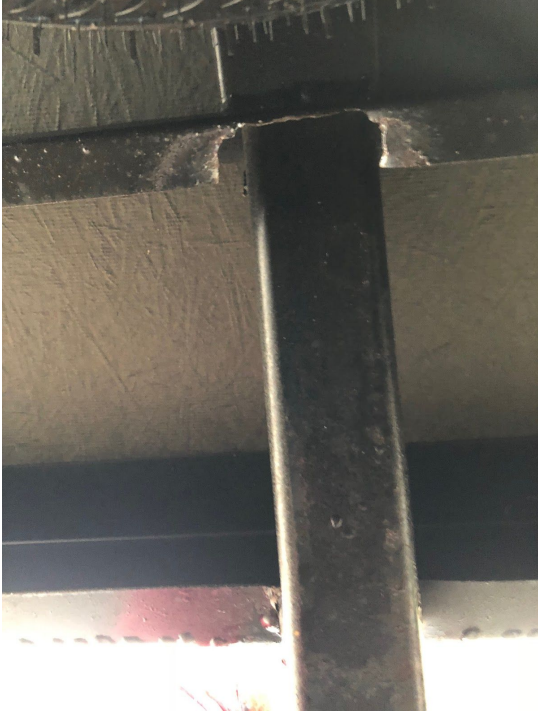
PROBLEM: It is possible for the rear receiver weld to break or bend due to rust or corrosion at the attachment point.

Broken weld on 2nd C channel in from rear bumper

CORRECTION: Additional piece(s) can be welded onto the chassis to better support the receiver rack and prevent failure.

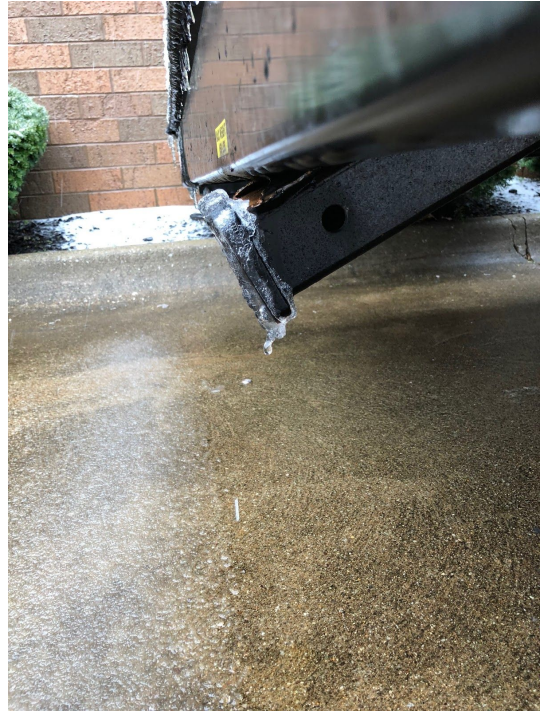
Broken weld forces receiver to bend
