## SERVICE BULLETIN #XTMMFX - 001

RE: Mini Max FX Grey Tank Vent Pipe System.

**MODEL:** Little Guy Mini Max FX.

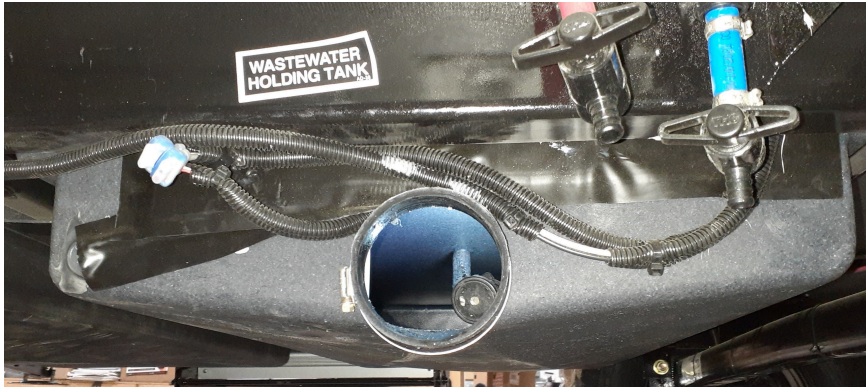
With the inlet assy. removed look inside the tank the white PVC Pipes should only be about 1" or so into tank from top of the tank rubber grommets. If they are too long like the pic. they will need cut off at the desired length of approximately 1" or drill a 5/8" hole with a spade bit and extension. See pic below:

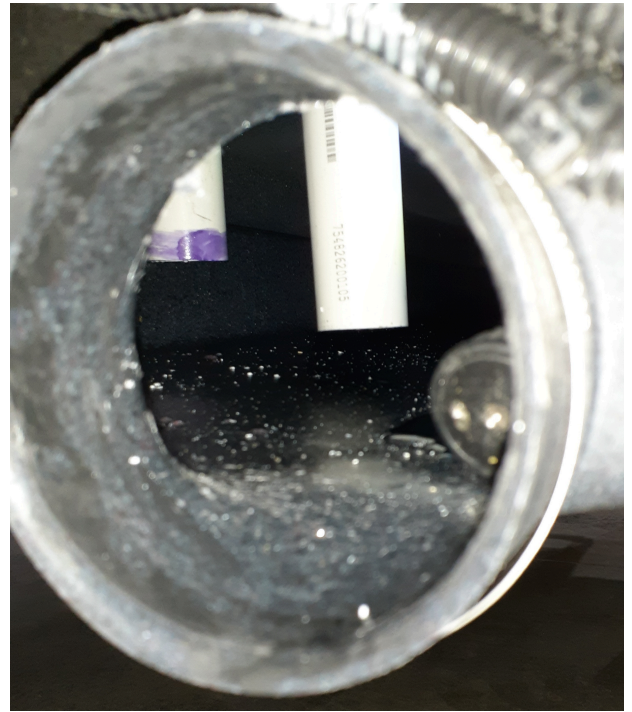
Pipe on the right needs to be cut to approx. 1" from the top of rubber grommet. see pic below.
