**SERVICE BULLETIN
#LO-003**

RE: Interior Shower Door

MODELS: Little Guy Max and Little Guy Mini Max

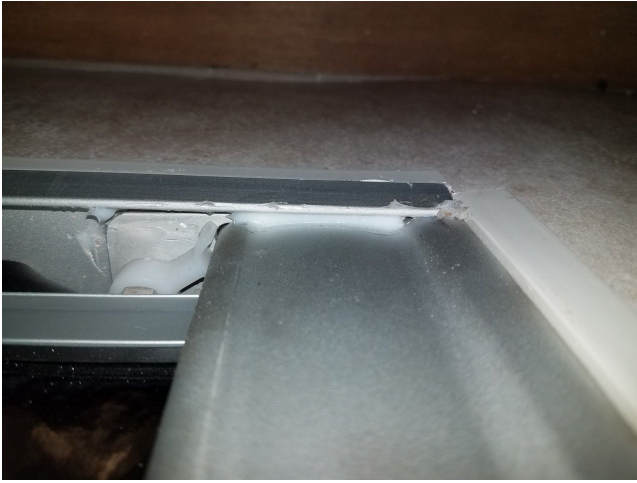
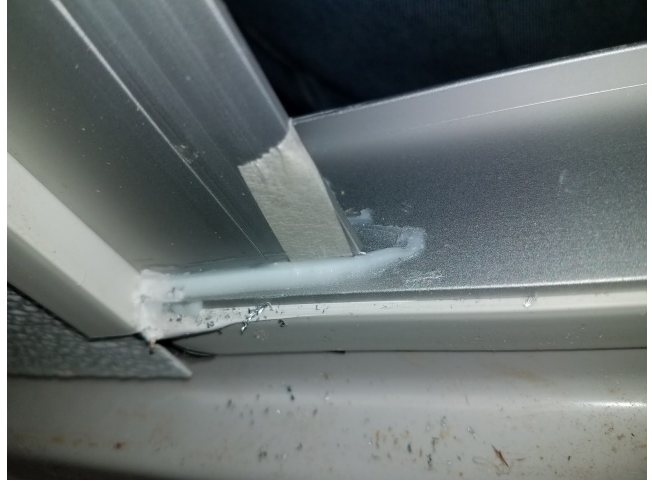
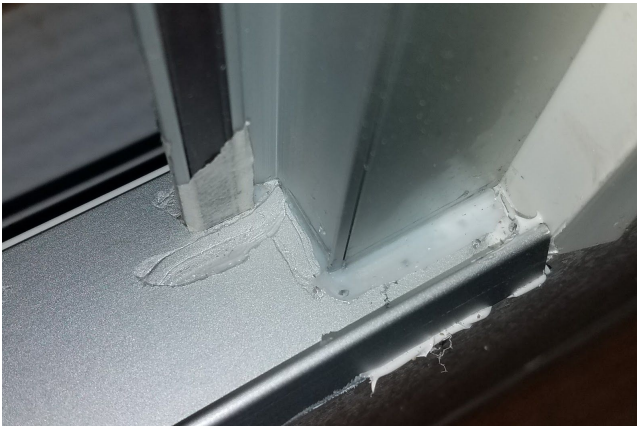
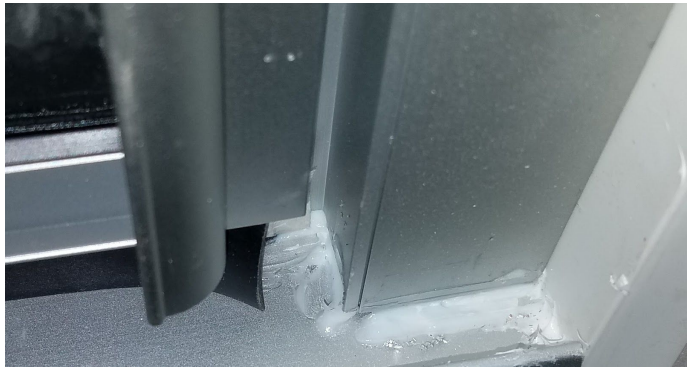
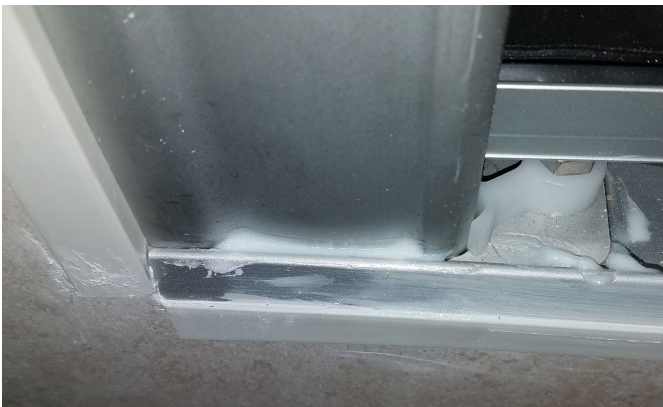
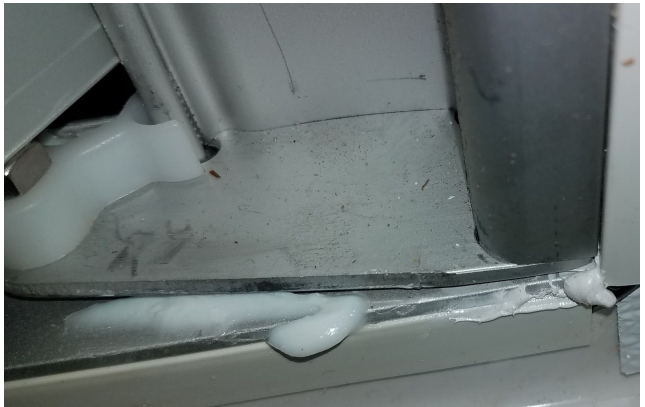
SHOWER DOOR SEALANT PICTURES

WHAT TO LOOK FOR: Over the past couple months it was brought to our attention that there was a problem with some of the Little Guy Max interior shower doors. After various tests we have diagnosed the problem as a shower door flaw/malfunction. The shower water can run down the glass door, enter the shower door track, follow the track to the outside of the door and flow over the edge causing water to run into the main cabin of the trailer. Applying sealant to various edges of the shower door (pictures below) will keep water from exiting the shower.

WHAT TO USE: Any brand of weatherproof caulk/silicone will work on the exterior of the unit. We use Crystal Clear and White Soudaseal Sealant.

SUMMARY: Applying sealant will keep water from exiting through your shower door. This new process of applying sealant to the shower has been used on the production line for the last month with positive results. This process has been used on Max's and Mini Max's. Your trailer may not be affected depending on when you have purchased it but we recommend taking a look at your shower door to verify.
