SERVICE BULLETIN #LO-005

RE: Black Tank Plumbing

OVERVIEW: This Service Bulletin covers the inspection and potential securing of the black tank plumbing

MODELS: Little Guy Max & Little Guy Mini Max.

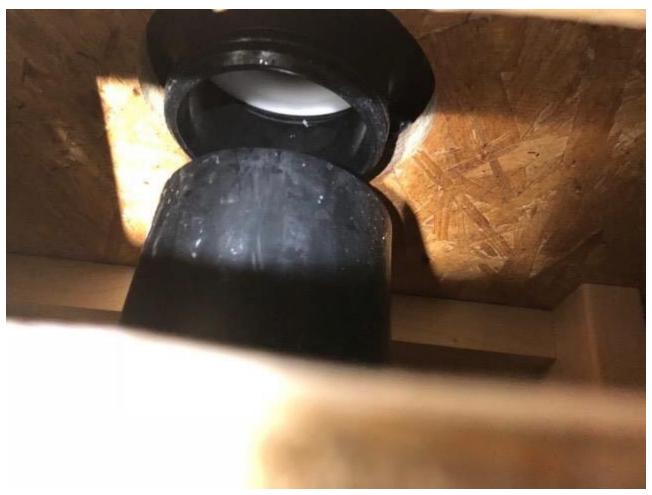
PROBLEM: The ABS tube which connects the exterior (undercarriage) black tank plumbing to the bottom of the black water holding tank could possibly come loose which can result in black water releasing into the interior of the trailer when the toilet is flushed.

A view from under the trailer right below the shower platform, this is the black tank drain and these are the two pieces that need glued together.

CORRECTION: Apply ABS cement at the connection point where the ABS pieces meet together to connect the internal black tank plumbing to the exterior (undercarriage) black tank plumbing.

NOTE: See picture on page 2, the picture represents the location which needs ABS cement
