SERVICE BULLETIN
#LO-007

RE: Mini Max Refrigerator Baffle

MODELS: Little Guy Mini Max.

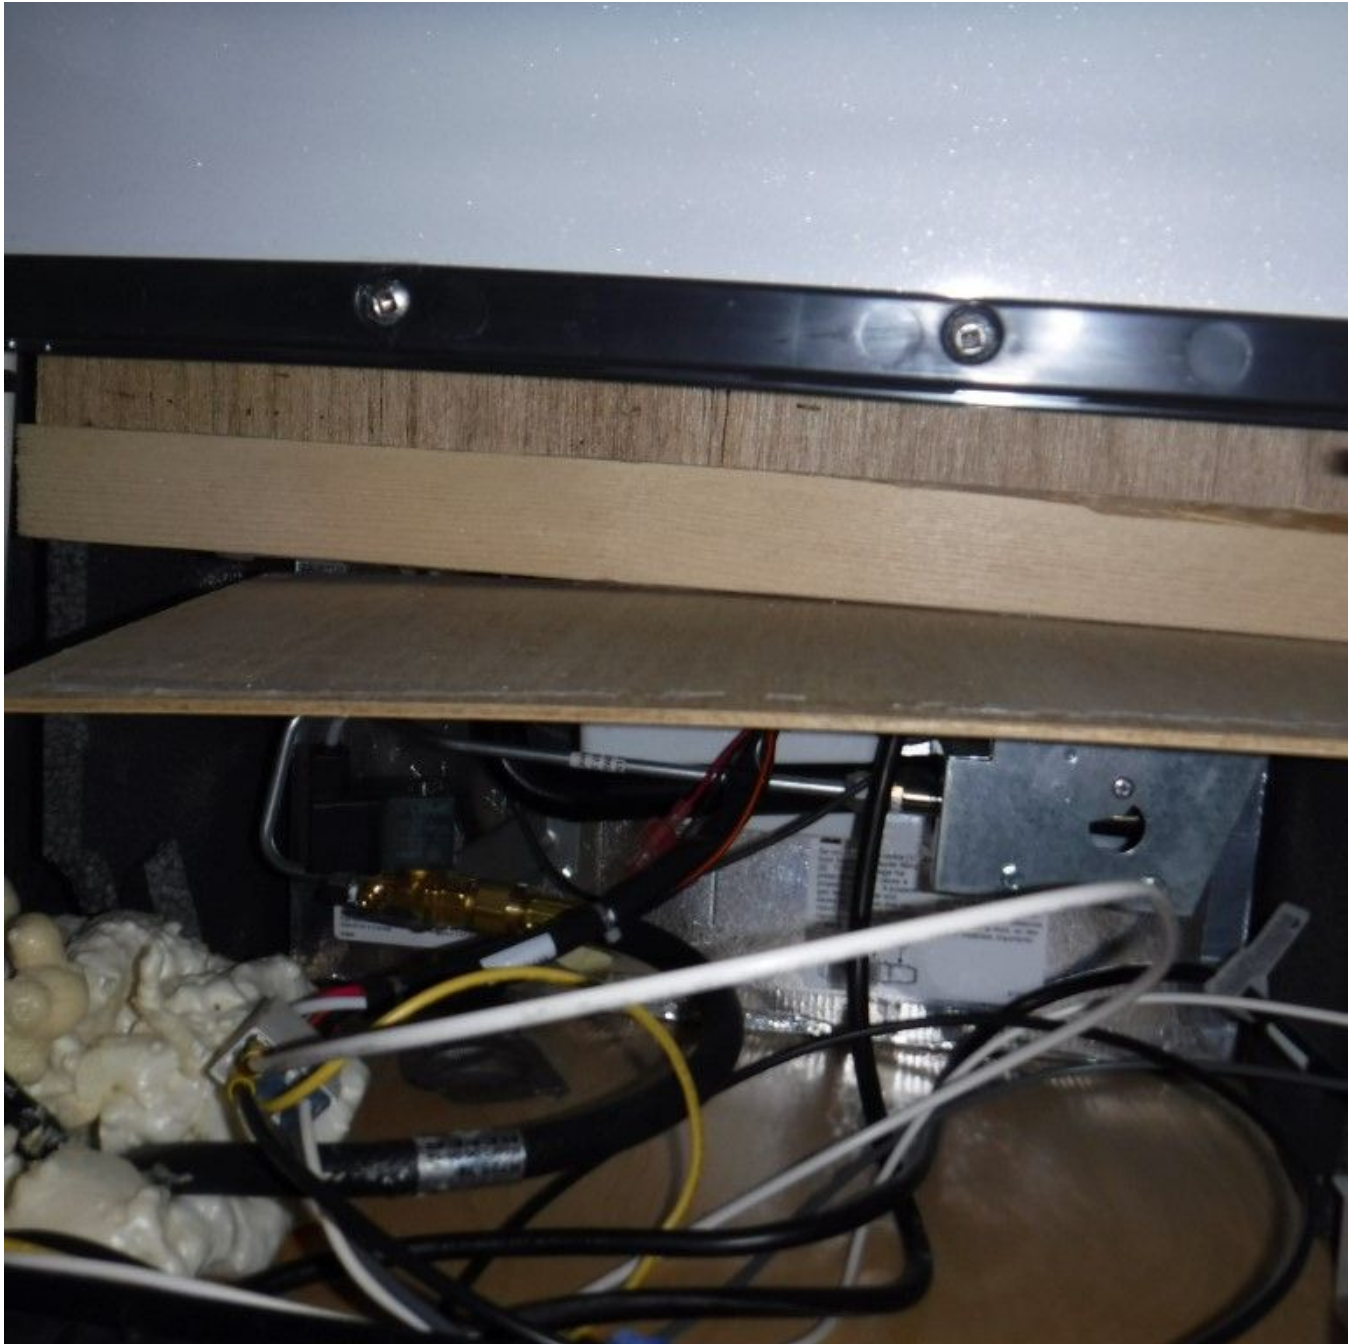
PROBLEM: It is possible for the fasteners to fail and the baffle will fall behind the fridge. This is dangerous due to the wood baffle potentially falling close to the fridges boiler tube which can get hot when the fridge is operating.

Baffle has broken and fallen down to the bottom of the fridge cabinet

CORRECTION: The baffle can be secured again to the fridge cabinet
