Service Bulletin : XTM-0002

Some axles installed on the LG MAX and LG Mini, may have been torqued outside the axle manufacturer's specification. This issue has the potential for the axle's hardware to break or become loose from the chassis.

LG MAX & LG MINI MAX

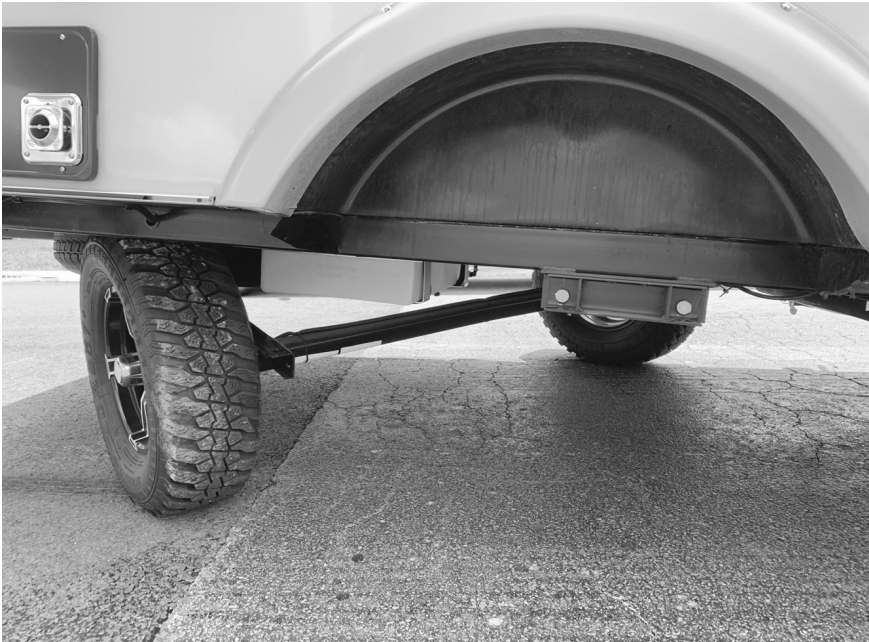
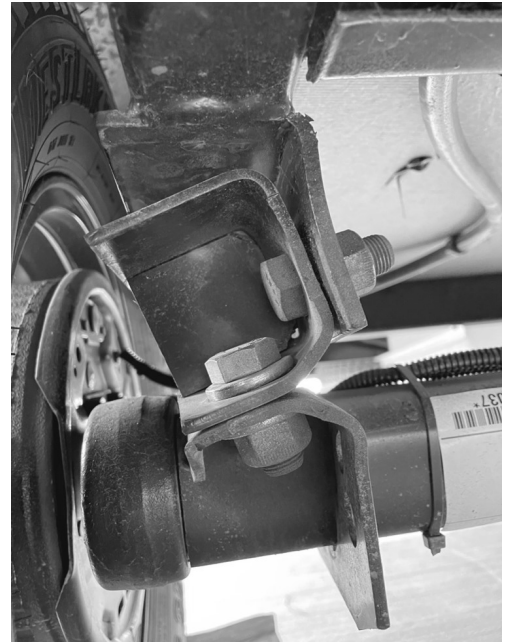
No components will need removed for this procedure.

Using a closed end wrench and torque wrench, tighten the 4 mounting bolts (per side) to the axle manufacturer's specification of 125—175ft.-lbs. (Shown Below)
