## SERVICE BULLETIN #XTMMFX - 001

RE: Mini Max FX Grey Tank Vent Pipe System.

**MODEL:** Little Guy Mini Max FX.

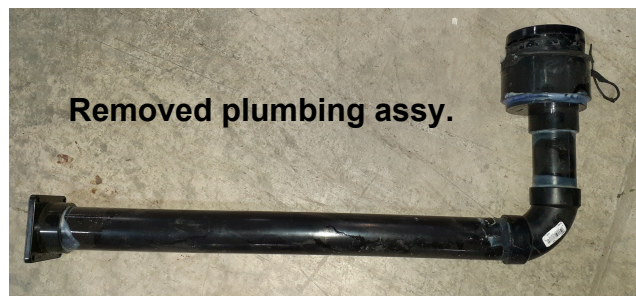
Remove the slicer valve bolts/nuts x4 on the Waste tank assy. and then loosen the hose clamp that is around the ABS reducer inlet on the grey tank assy. remove hanger strap and pull out the plumbing assy. from the grey tank assy.
